Product Service Bulletin

All 2.50" Tandem Side-Door Stripper/Packers

PSB-035

September 1996

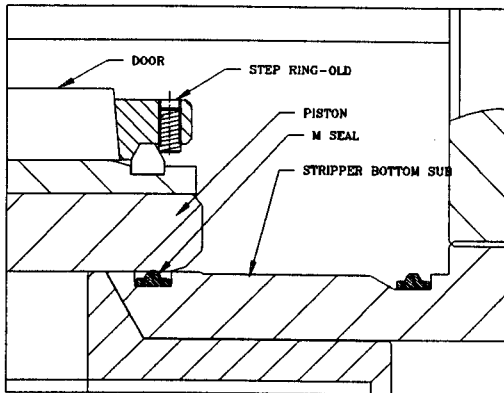
EXISTING ARRANGEMENT

It has come to Texas Oil Tool's attention that there is a fault with 2.50" Tandem Side-Door Stripper/Packers; namely that the main 'M' seal in the bottom sub can extrude at higher pressures. This condition only occurs when the piston is being pressurised to retract, but with the doors closed, eg, when pressure testing the upper stripper.

The remedy for this potential occurrence is to change out the existing step ring (part number 9101-2926) with a new, longer ring (part number 9628-2120), see sketch below for details of change.
