**Product:**

15K "ES" BOP

Prepared by:	TOT 15,000psi Working Pressure "ES" BOP	<b>PSB-050</b> February 2001 Page 1 of 3
Approved by:

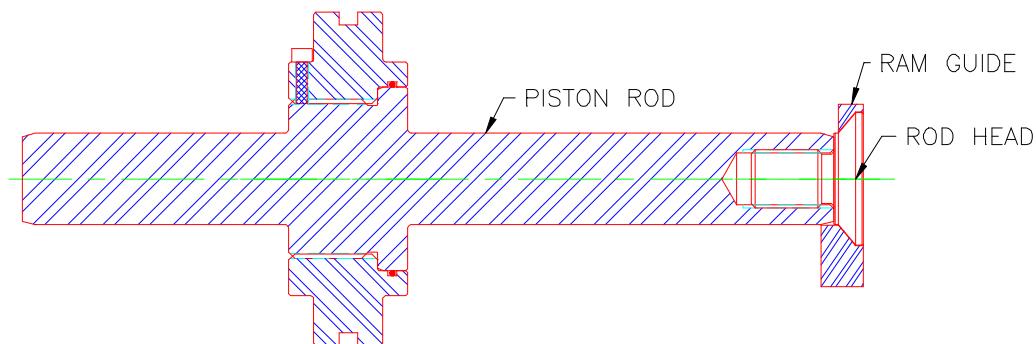
Pipe, Slip, and Blind Rams on the Quad: See drawing ES46-T011-1

An incident occurred in the field with a piston rod and the piston rod head. The piston rod head sheared off while opening the rams. A restriction prevented the ram from retracting normally and the load induced on the rod head sheared it off.

New Rod Head part number 9905-2833 rev. C

New Ram Guide part number 2001-0024 rev. -
