Coating technologies extend geothermal plant operation – without chemicals

Taking lessons learned from the oil and gas industry, geothermal operators are applying internal coatings to mitigate corrosion and scaling.

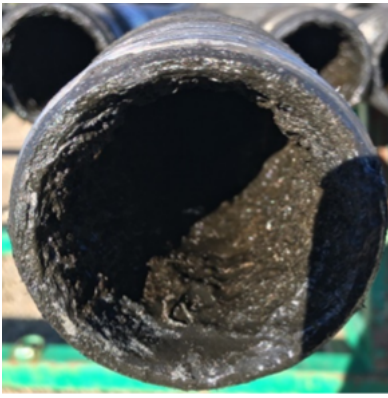
Uncoated L-80

Figure 1 – Inspection of the tubing pulled from the Canadian well showed inorganic and organic solids deposits on the uncoated pipe, while the IPC-coated pipe was largely deposit free.

The tubing string exhibited a loss in pressure after one year in service, which was attributed to a hole in a joint of uncoated tubing. As a result, the entire tubing string was pulled and inspected. The uncoated tubing contained a layer of oil and solids deposits, while the IPC tubing was nearly deposit free (Figure 1).

Inspection of the pipe wall, which was carried out in accordance with a color-coding system designed by the American Petroleum Institute (API) known as API Spec 5CT, categorized the uncoated tubing as 46% blue, green, and red band. This indicated that the remaining wall thickness of the uncoated tubing was between 70% to less than 50% of the original, nominal wall thickness. The remaining uncoated tubing was designated yellow band, meaning that the remaining wall thickness was 85%. The hole was found in the third joint of tubing above the internally coated section of the string.
